DYNAMIC SCIENCE, INC.
In-Depth Accident Investigation

Contract DTNH22-87C-47169
Case DSI-93-AB-010

TECHNICAL SUMMARY

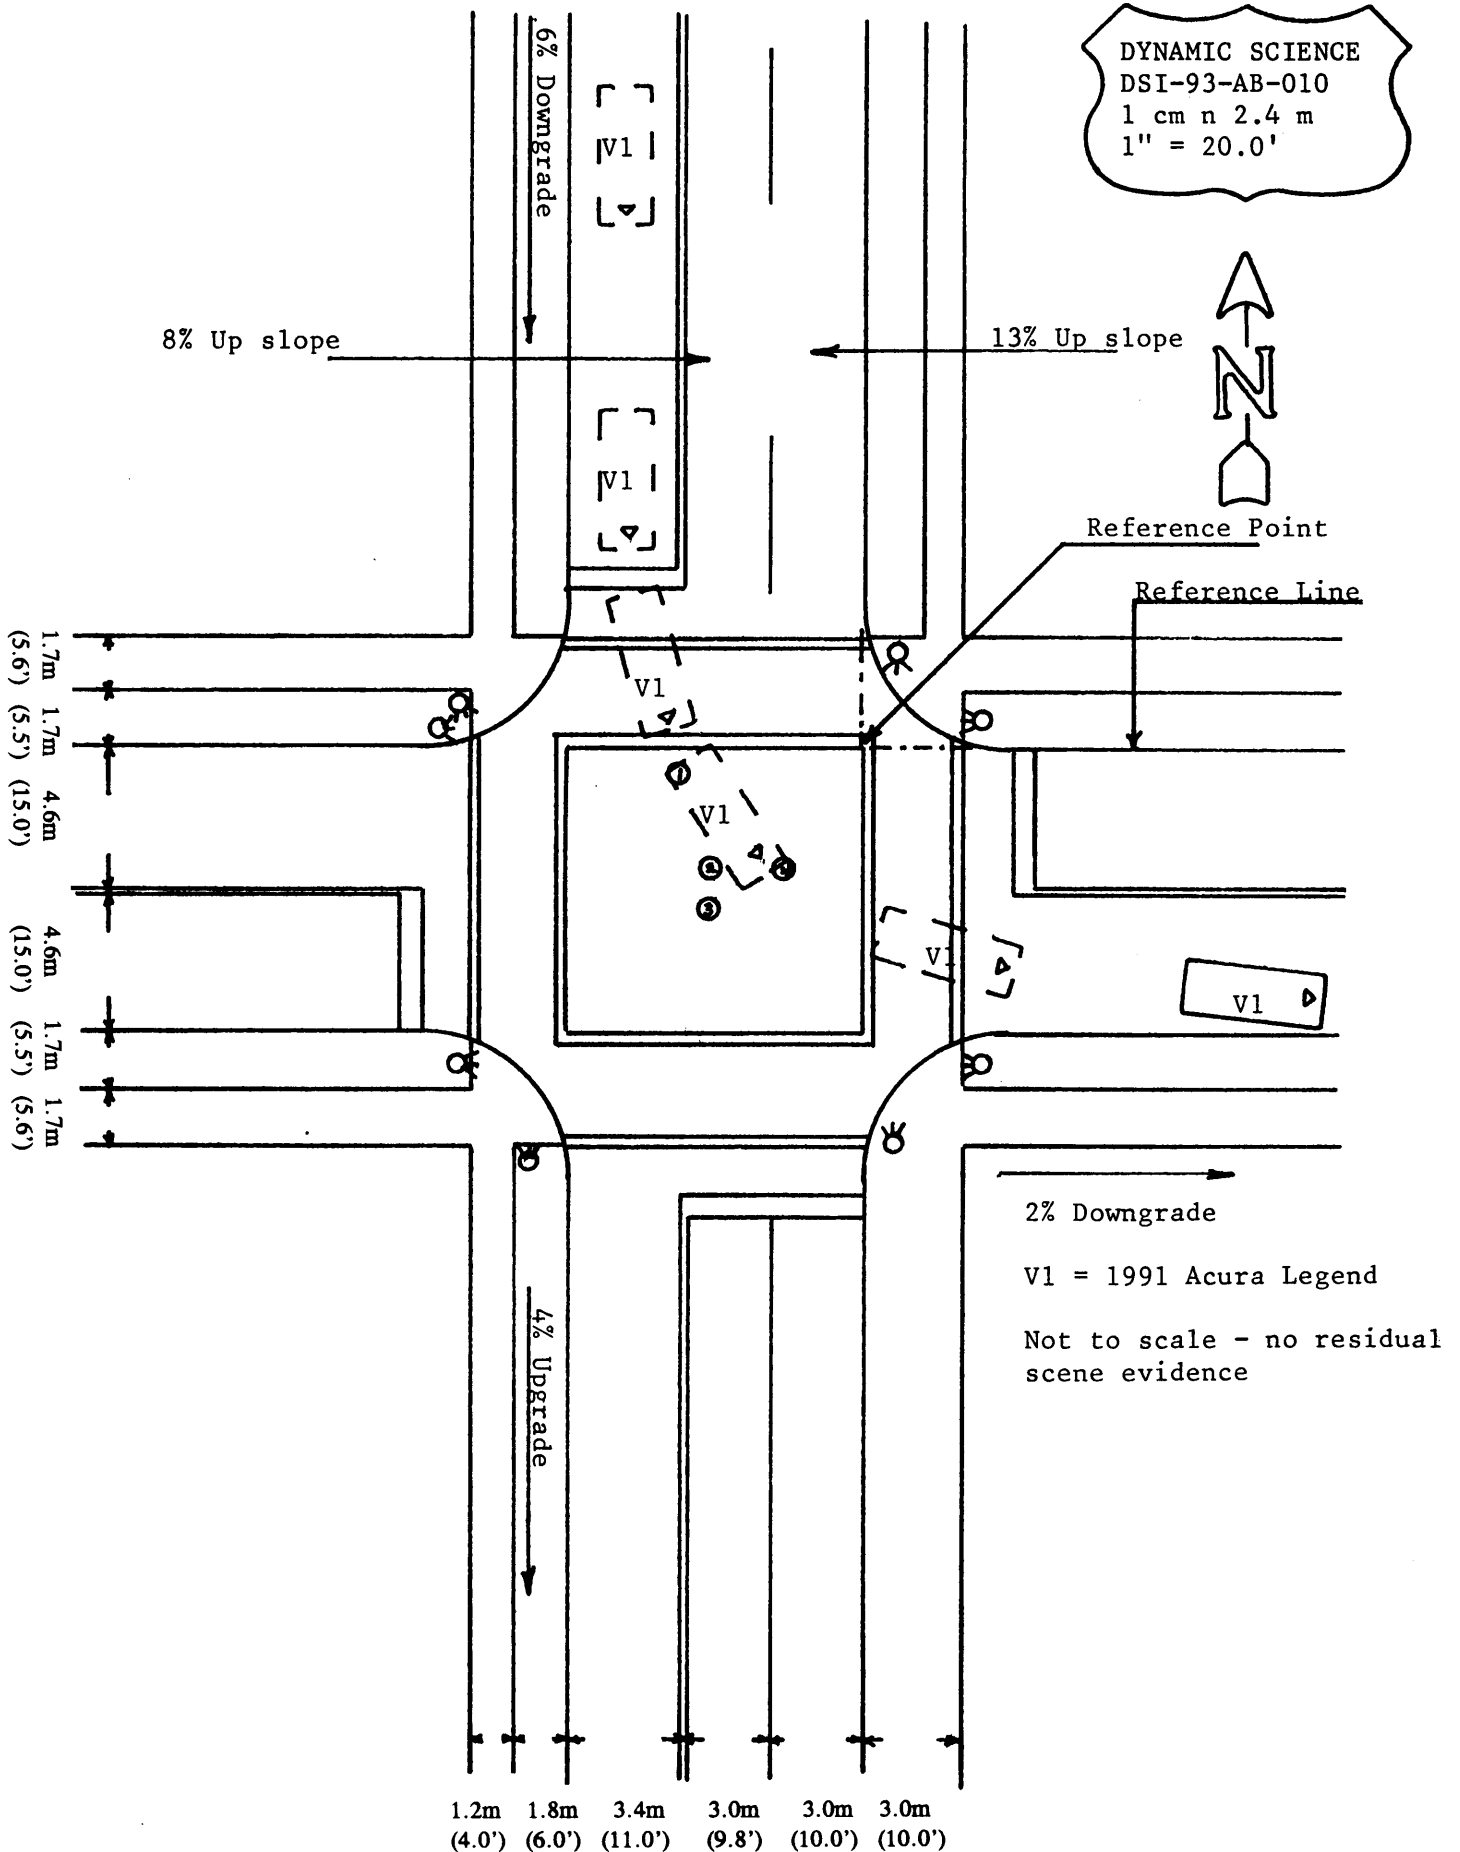
COLLISION MEASUREMENTS

DATA POINT	LONGITUDINAL S	LATERALS
East curb, north/south roadway	0	15.2 c (50 ft) N
Broken, white painted line	3.0 m (10 ft) W	15.2 c (50 ft) N
Double, yellow painted line	6.0 m (19.8 ft) W	15.2 c (50 ft) N
West curb, north/south roadway	9.4 m (30.8 ft) W	15.2 c (50 ft) N
North curb, east/west roadway	9.1 m (30 ft) E	0
Double, yellow painted line	9.1 m (30 ft) E	4.6m (15.0 ft) S
South curb, east/west roadway	9.1 m (30 ft) E	9.1m (30.0 ft) S
POI (manhole # 4)	2.7 m (8.9 ft) W	3.4m (11.3 ft) S
Manhole # 1 (center) Approximate height above road surface = 11.7 cm (4.6 in)	5.8 m (19.1 ft) W	.9 m (2.8 ft) S
Manhole # 2 (center) Approximate height above road surface = 10.2 cm (4 in)	5.1 m (16.8 ft) W	3.8m (12.4 ft) S
Manhole # 3 (center) Approximate height above road surface = 10.2 cm (4 in)	5.1 m (16.8 ft) W	5.1 m (16.6 ft) S
Manhole # 4 (center) Approximate height above road surface = 19.1 cm (7.5 in)	2.5 m (8.3 ft) W	3.9 m (12.7 ft) S

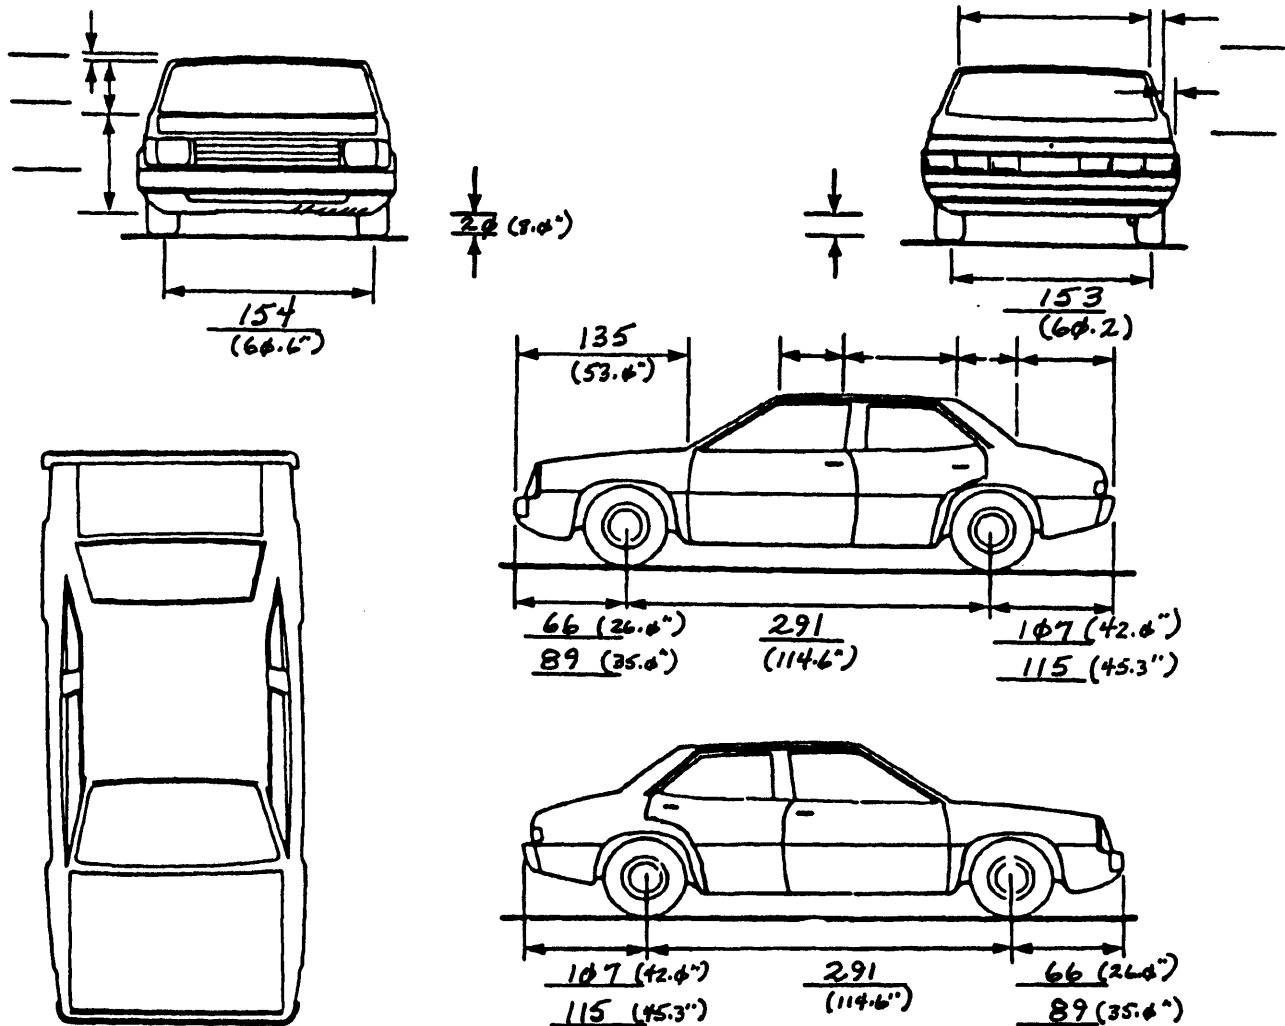
VEHICLE DAMAGE SKETCH

Specific Impact No.	Location of Direct Damage	Location of Field L
Ø1	LEFT FRONT UNDERCARRIAGE	NOT MEASURED

Accident Event Sequence Number	Object Contacted	(1) (2) Direction of Force	(3) Deformation Location	(4) Longitudinal or Lateral Location	(5) Vertical or Lateral Location	(6) Type of Damage Distribution	(7) Deformation Extent
4. <u>Φ 1</u>	5. <u>6 B</u>	6. <u>Φ Φ</u>	7. <u>L</u>	8. <u>Y</u>	9. <u>L</u>	10. <u>N</u>	11. <u>Φ 2</u>

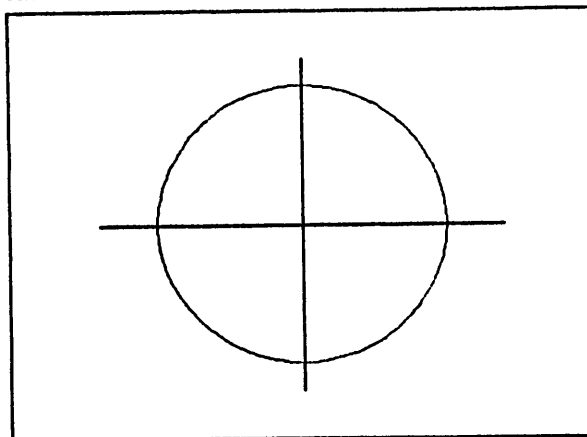
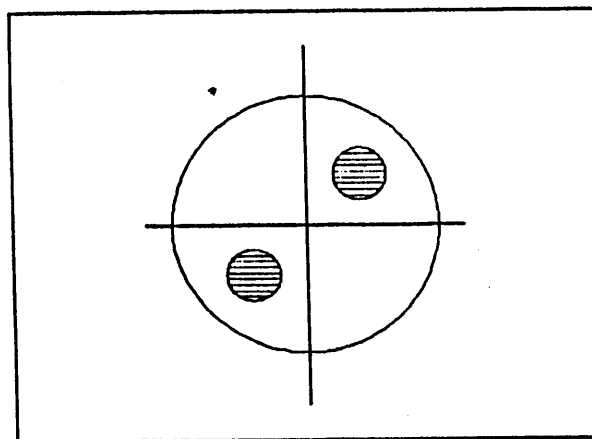
AIRBAG SUPPLEMENT

The airbag was not damaged during the accident sequence and did not yield evidence of occupant contact. The airbag measured 63.5 cm (25 in) in diameter in its deflated, post-accident state. The airbag was vented by two ports located on the back side of the bag (away from the driver). The 3.8 cm (1.5 in) diameter ports were located at the 10:30 and 1:30 o'clock

DESCRIBE SYSTEM AND BAG DAMAGE: *NONE*NOTE DAMAGE AND CONTACT MARKS ON AIRBAG DIAGRAMS
BELOW: *NONE*
